TS-PIC-20202335S
May 2002

AERIAL PHOTOGRAPHIC ANALYSIS OF STANDARD CHLORINE CHEMICAL CORPORATION SITE Kearny, New Jersey

AERIAL PHOTOGRAPHIC ANALYSIS OF
STANDARD CHLORINE CHEMICAL CORPORATION SITE

Kearny, New Jersey

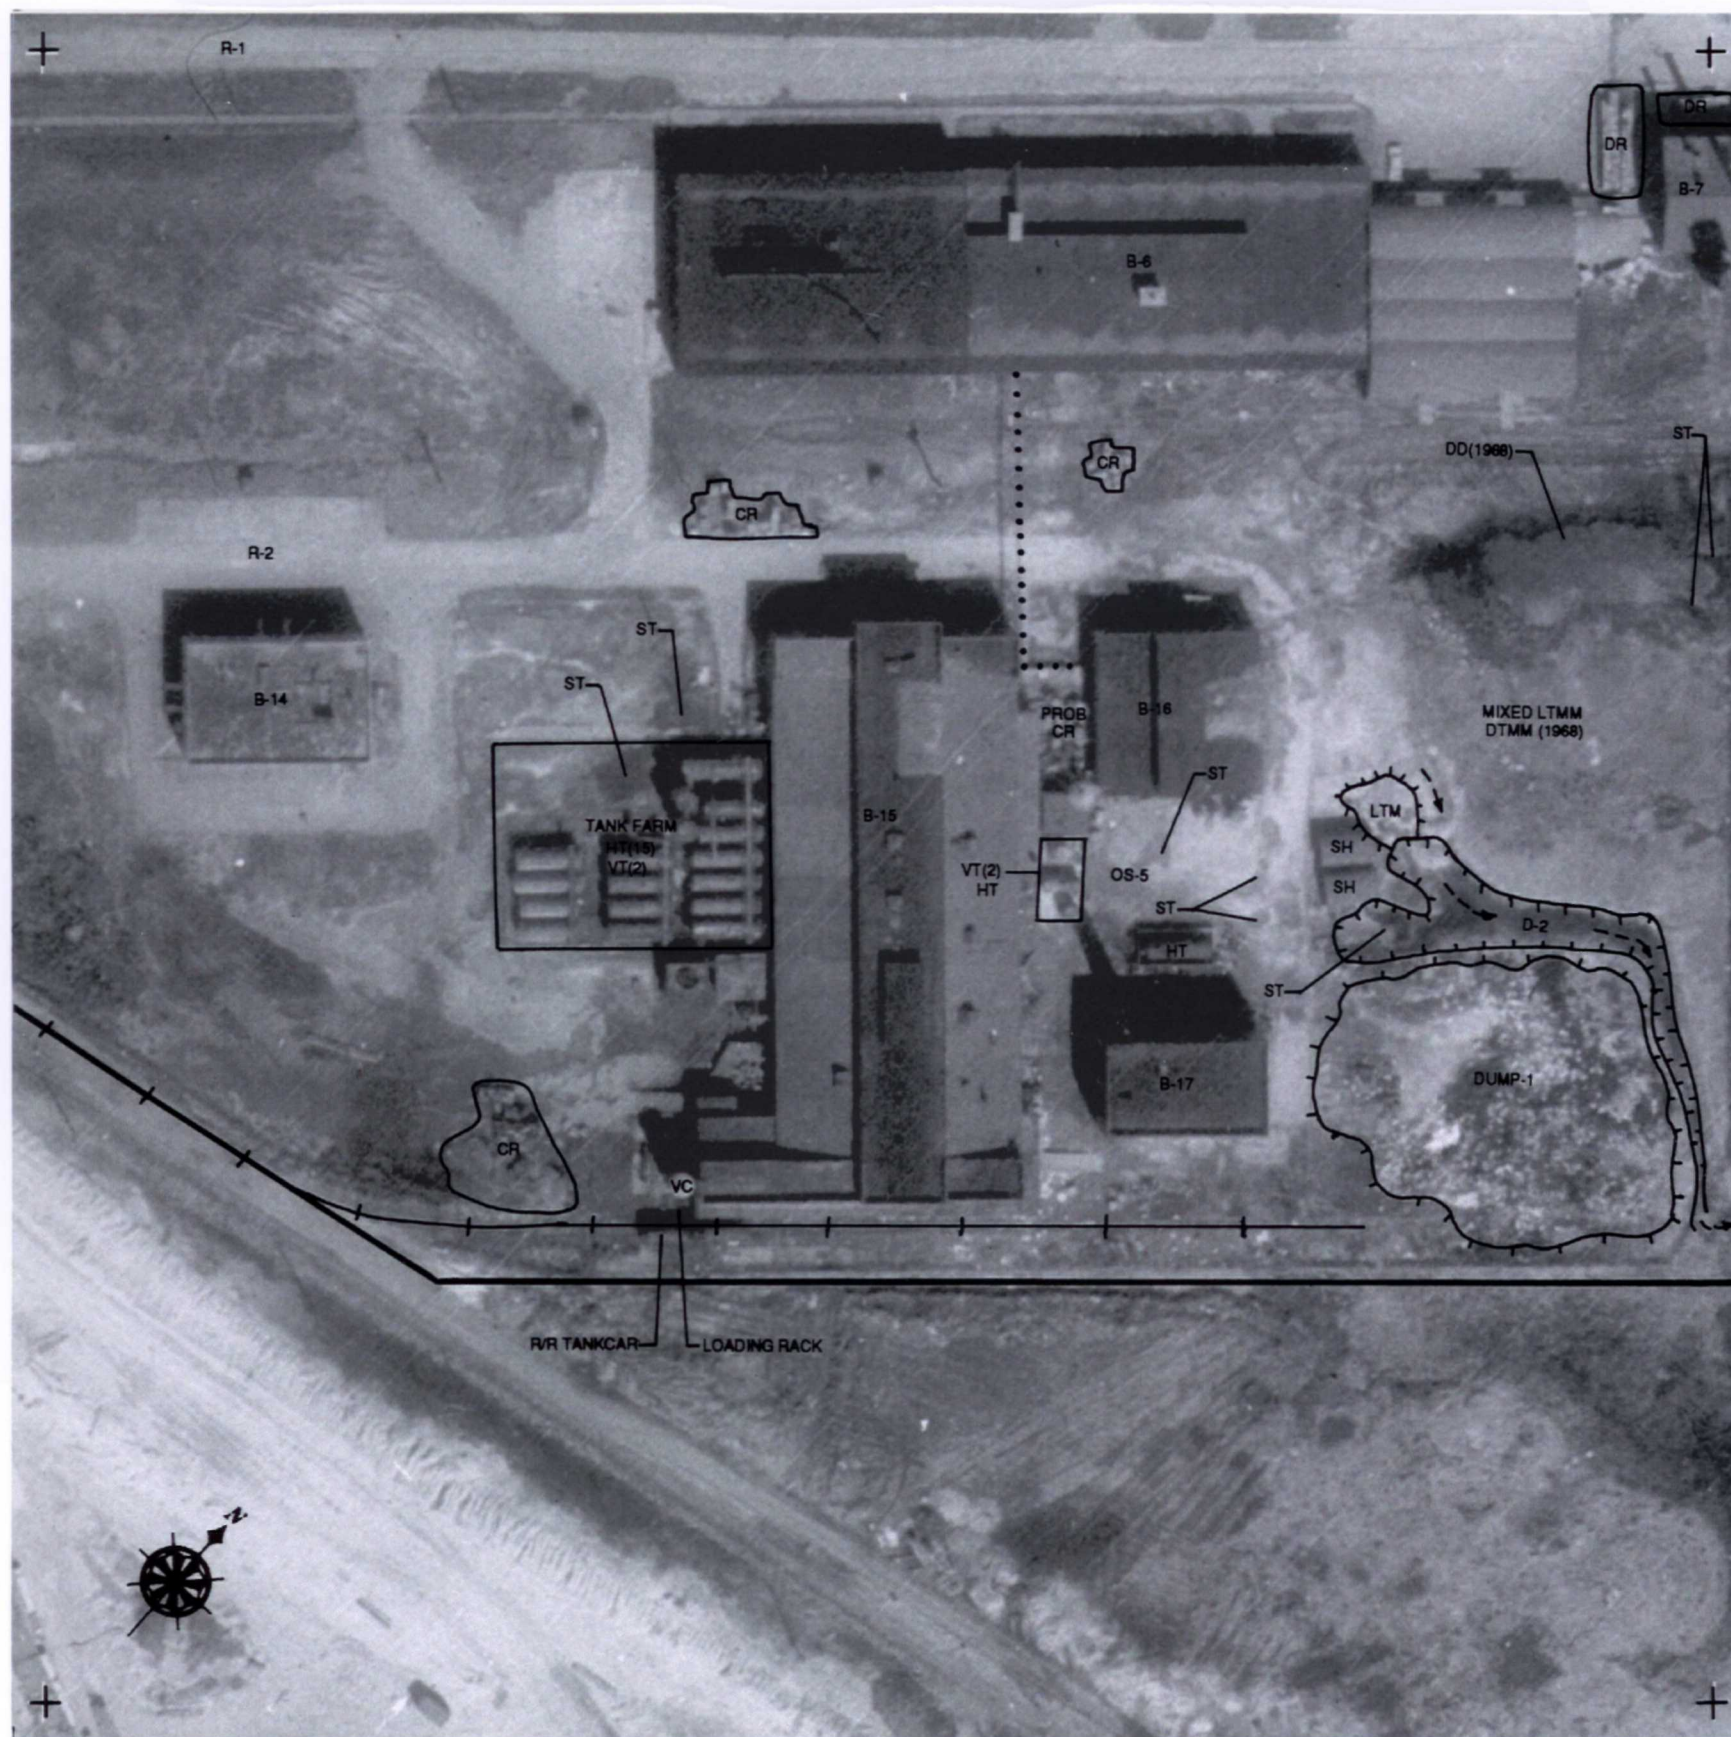
Figure 17. Standard Chlorine site, April 16, 1973. Approximate scale 1:1,100.

APRIL 16, 1973 (FIGURE 17)

The Dump-1 east of building B-17 continues to accumulate possible debris, and mixed light- and dark-toned material. Drainage ditch D-2 receives possible discharges from buildings B-16 and B-17 and potential contaminated runoff from this portion of the site. An outfall (OF) plume is discerned at the terminus of drainage ditch D-2 as it enters the Hackensack River suggesting the presence of a culvert not previously discerned. The runoff from this ditch appears to also enter the wetland area south of the site.

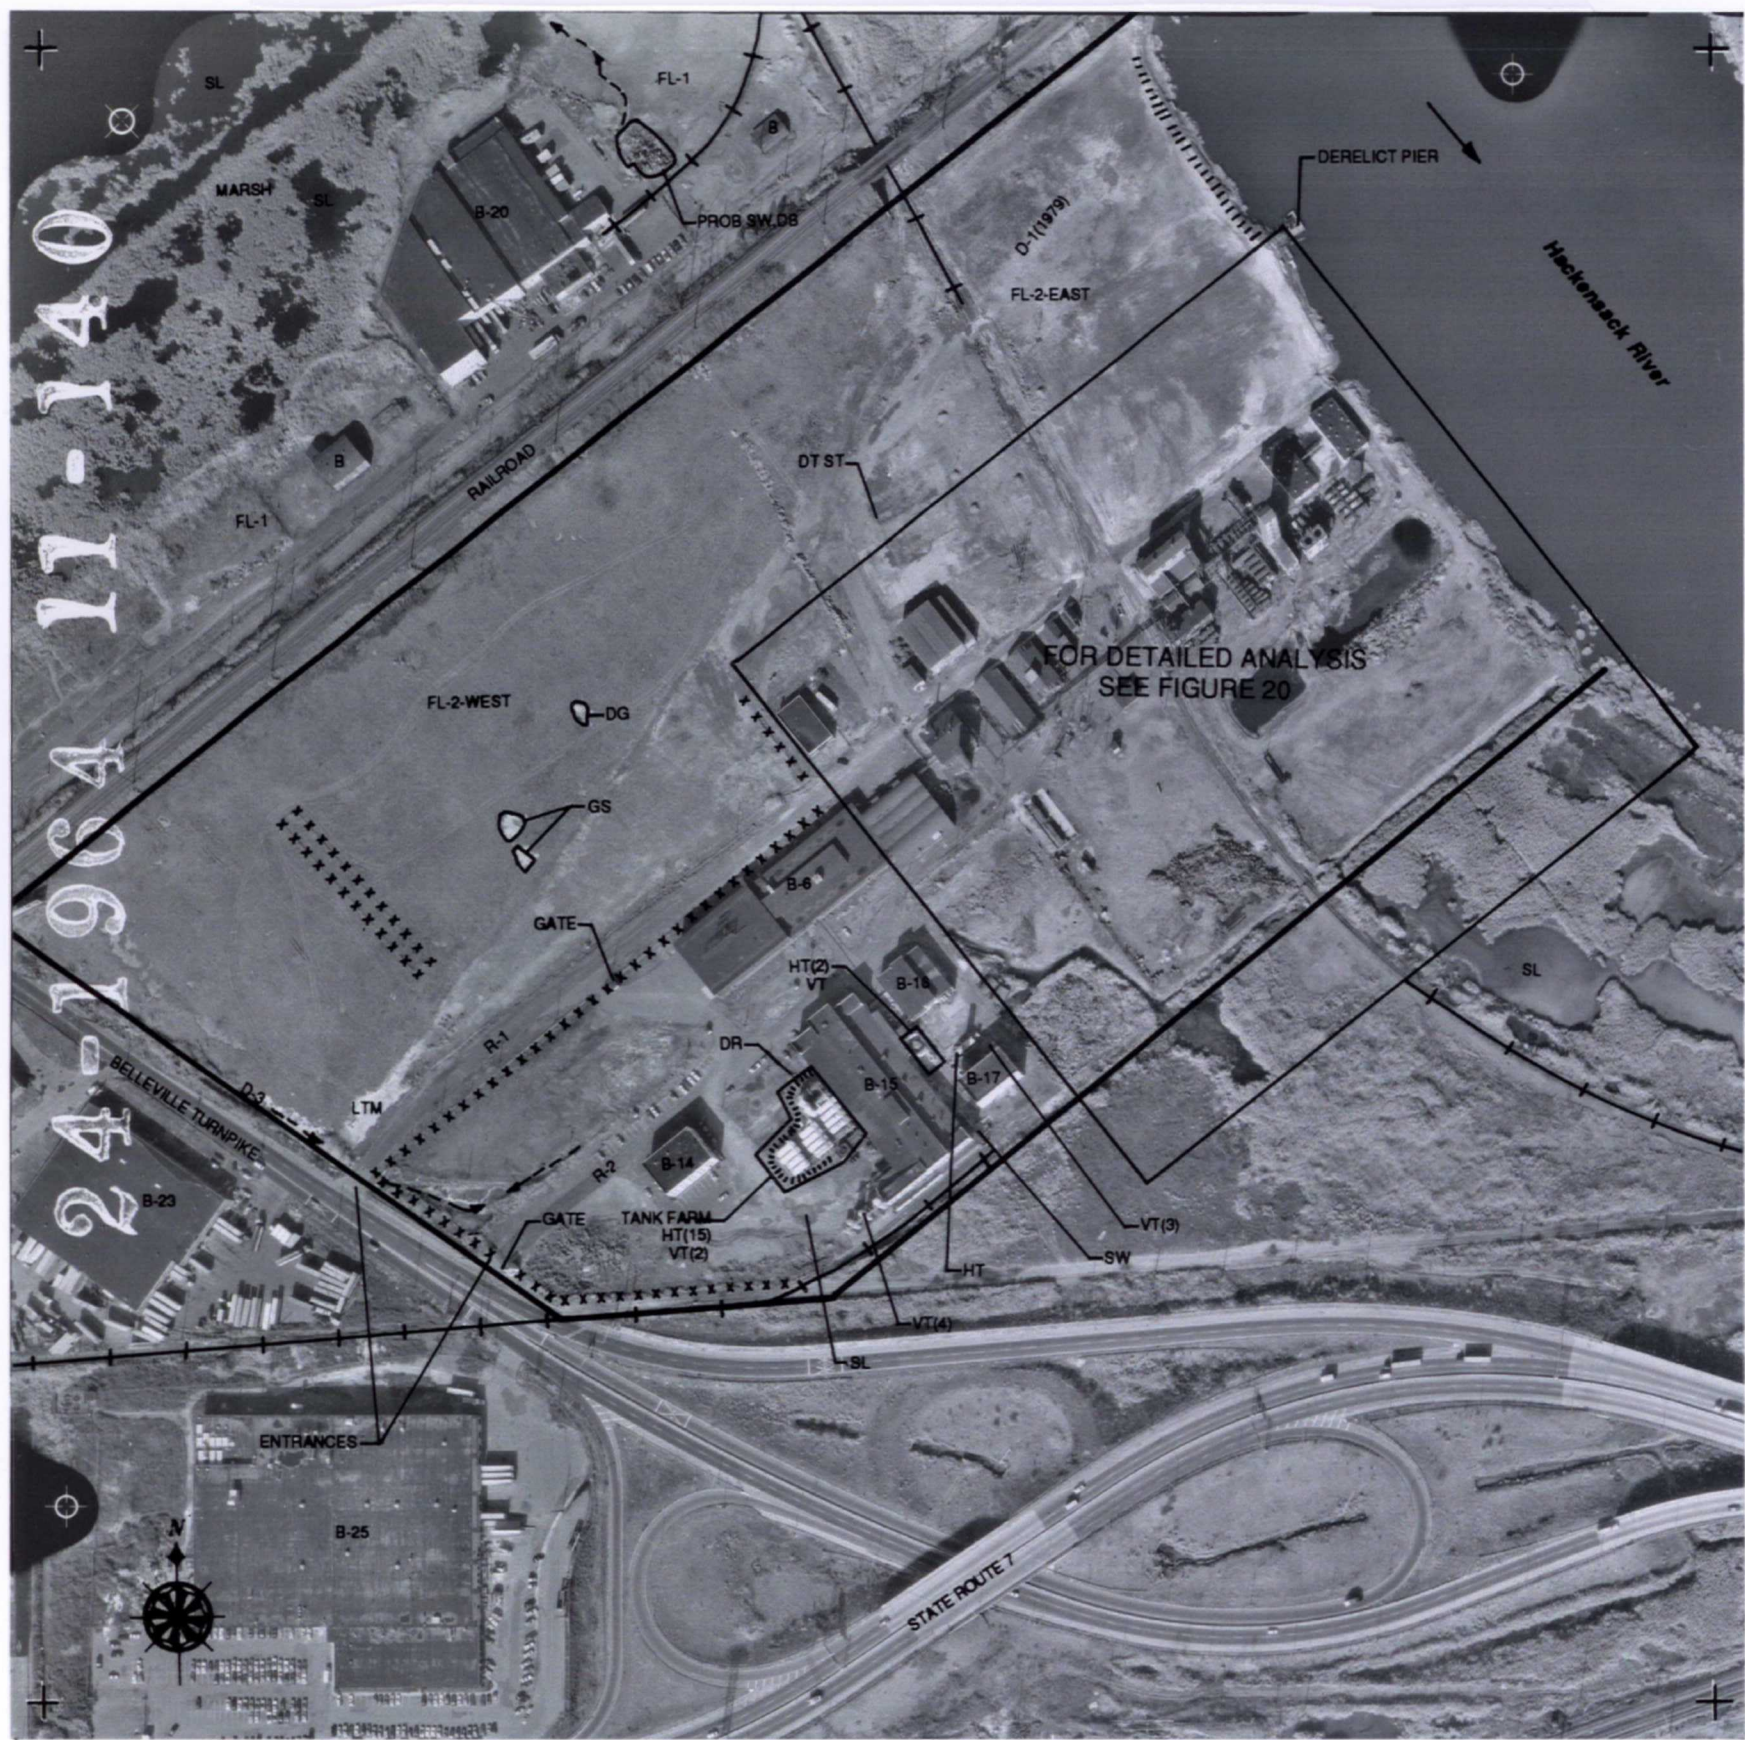
Figure 20. Standard Chlorine site, November 8, 1982. Approximate scale 1:1,440.

As a result of improved resolution of this photograph, three vertical, possible storage tanks are discerned on the north side of building B-17 and a group of 55-gallon drums are visible on the east side of building B-17 (see Figure 20).

NOVEMBER 8, 1982 (FIGURE 20)

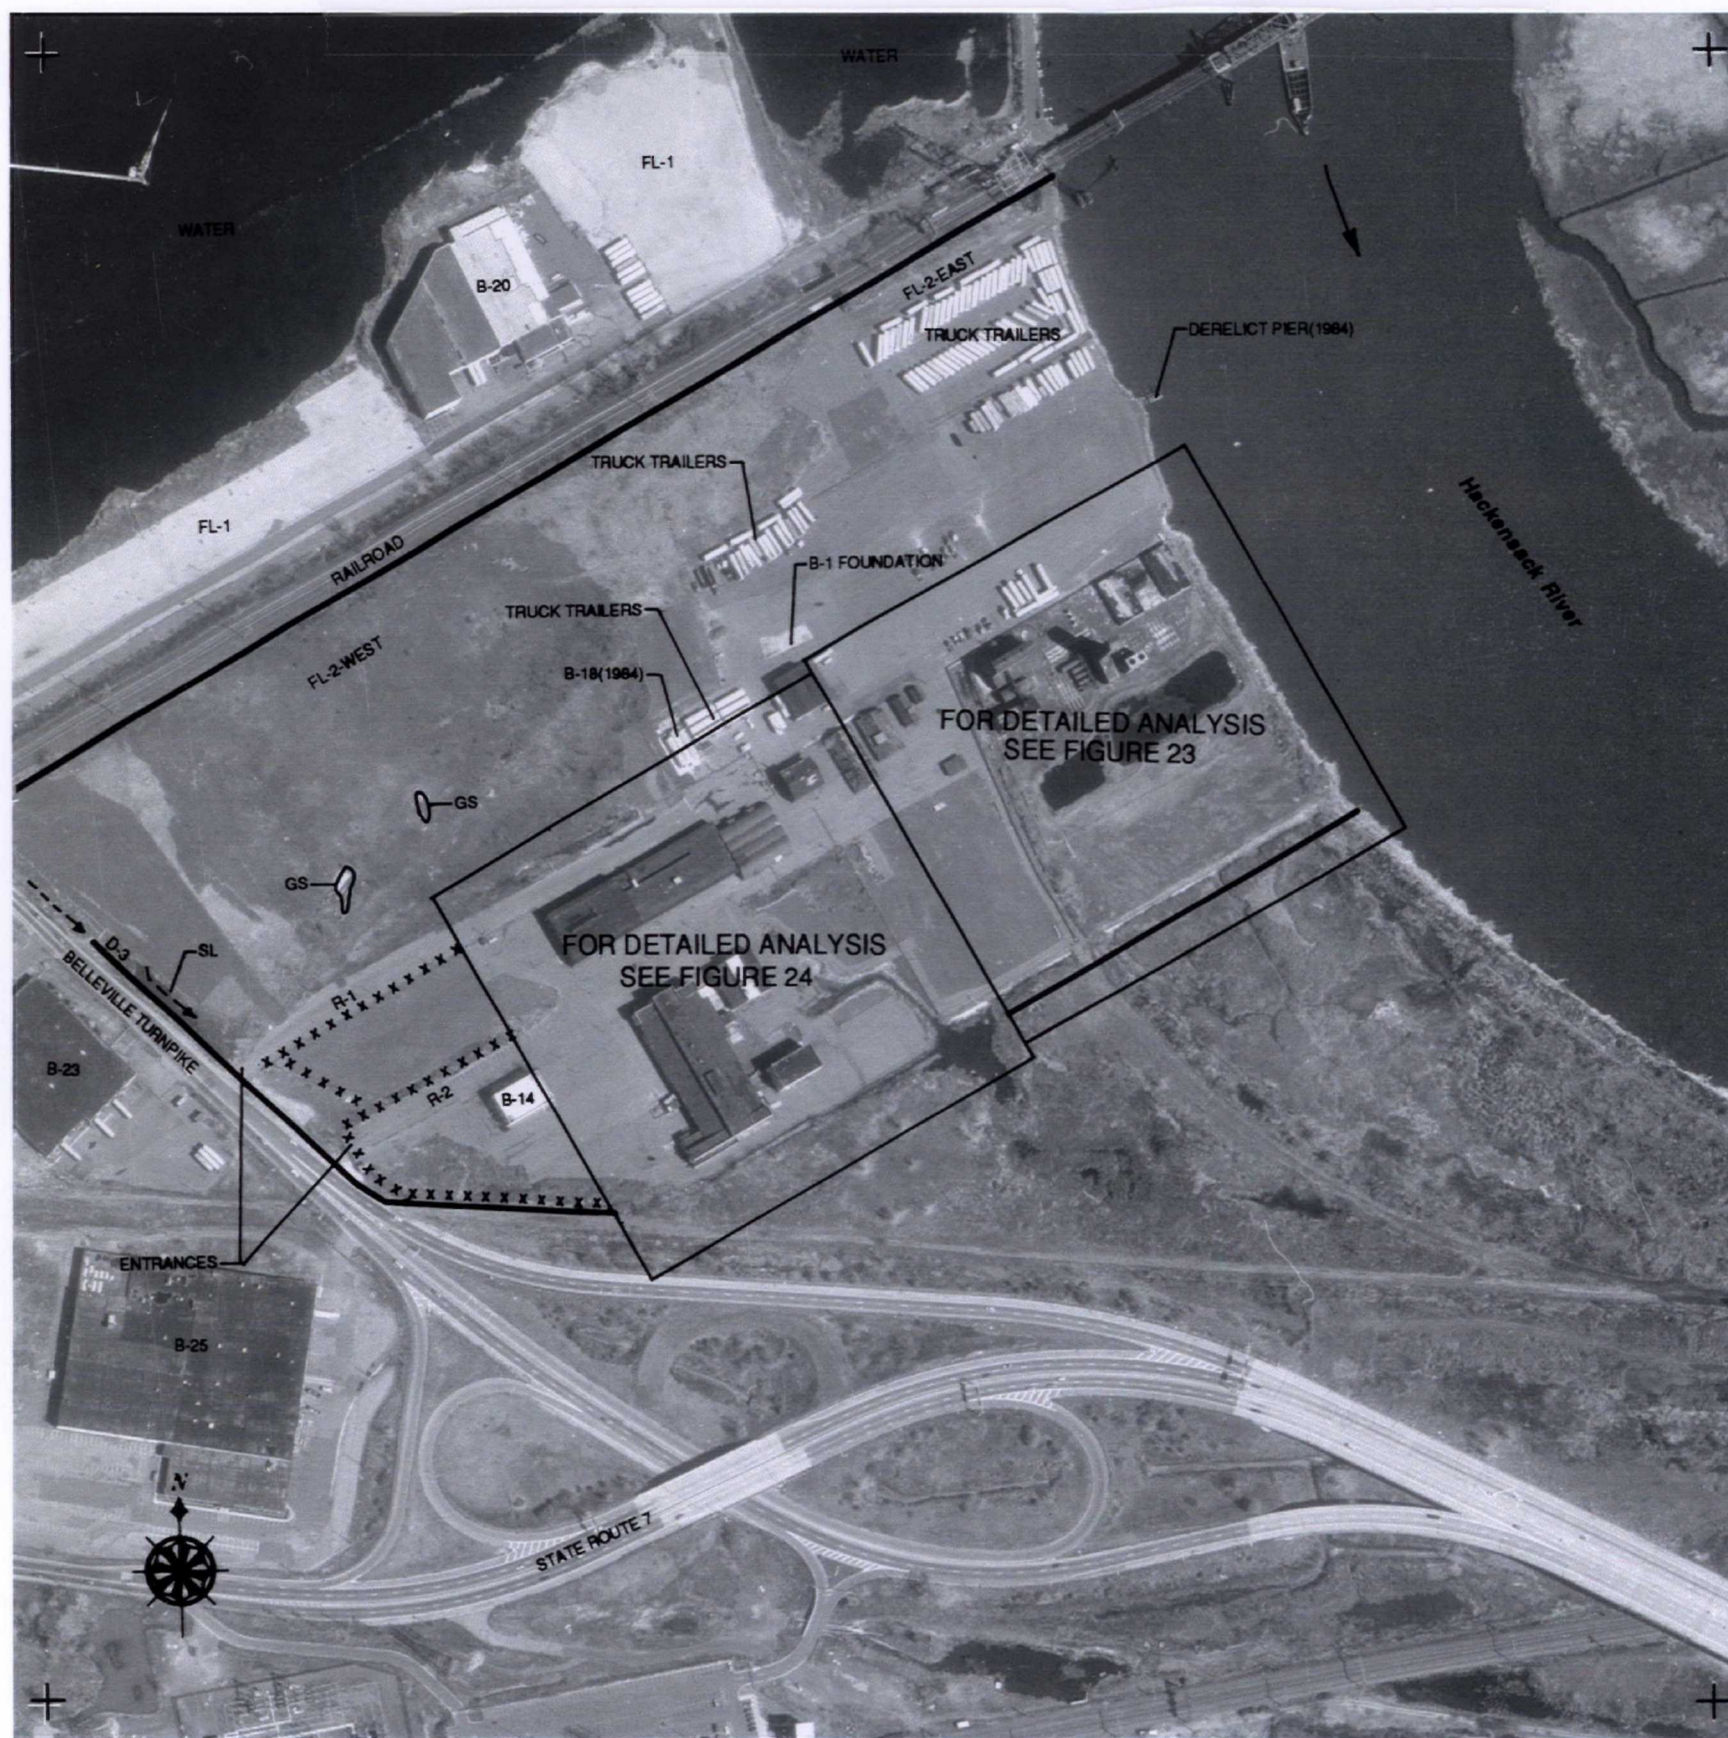
Figure 23. Standard Chlorine site, April 16, 1995. Approximate scale 1:1,070.

APRIL 16, 1995 (FIGURE 23)
